THE BLATNÁ WATER DITCH – AN EXAMPLE OF CONNECTING MULTIPLE INTERESTS WHILE PRESERVING A FUNCTIONAL MONUMENT OF TECHNICAL HERITAGE

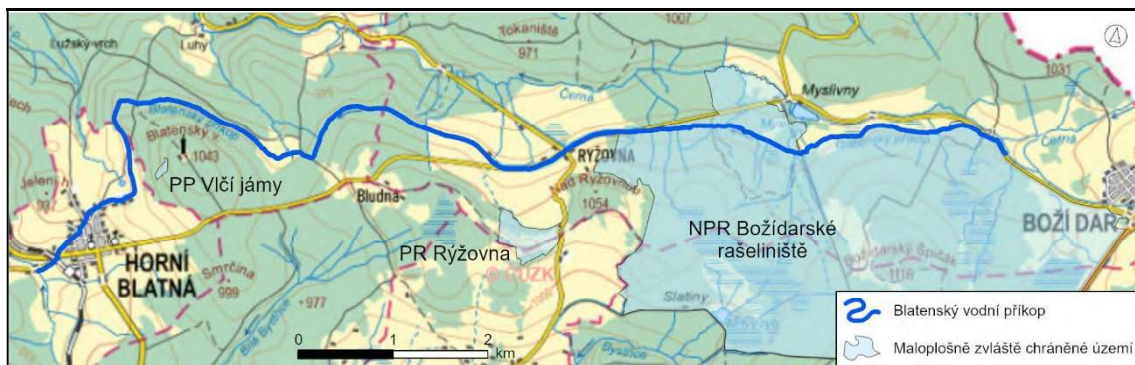
Fig. 1: The Blatná water ditch route

According to written sources, the Blatná water ditch was built at the turn of the 1540s by a person called Stephan Lenk, not long after the discovery of tin deposits in the vicinity of Blatenský hill and the subsequent foundation of the town of Horní Blatná (1532). An almost 12 km-long water ditch with an average slope of 3 ‰ was started to the west of Boží Dar, where it took water from Černá Brook, from where it led through Myslivny, Ryžovna, Bludná, along the northern slope of Blatenský Hill to Horní Blatná (Fig. 1), where its water provided the propulsion power for the equipment and machinery in mining and processing operations (the crushing and smelting plant of extracted tin ore) situated to the west of the core of the town buildings. To the south of the town the ditch led into the Blatenský Brook. From the early 1870s, the Blatná water ditch operated under the name of a newly formed water cooperative based in Horní Blatná. The water ditch served its function and was maintained till the displacement of the local German population after the Second World War. Then it lay decaying for half a century (Cais, 2018).

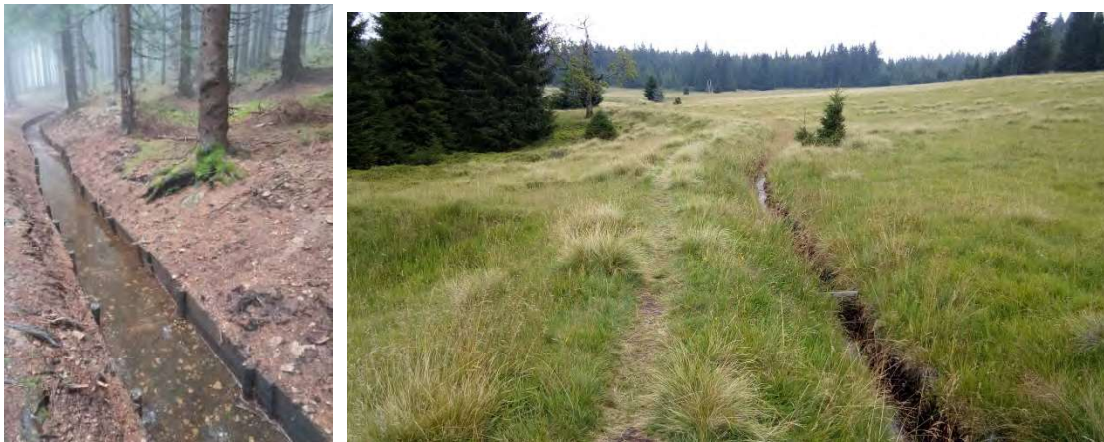
The water ditch is about 2 metres wide and over 1 metre deep (Fig. 2). Its trough was reinforced with wooden battens or lined with stone cladding and in the past it was covered year round. The whole works was equipped with necessary technical elements which ensured the desired function. It involved: (i) a system of sluice gates; (ii) supply and drainage branch channels; (iii) traps for gravel and sand deposits drifted by the current of tributaries which supplied water to the ditch; (iv) overflows which, on the contrary, served to drain an excessive amount of water from it into the Černá River; (v) culverts under roads; (vi) bridges over the ditch or water transfer (via aqueduct) allowing crossing the brook. They could be used to carry out regular walking inspections of the ditch (nowadays they are often used by tourists), check its flow rate and remove any obstacles or repair damage to the structure.

Fig. 2: Channel of the ditch in a forest area (left) and in an open landscape (right)
